NASA  
Technical Memorandum 106626  
AIAA-94-2710

# Compliant Metal Enhanced Convection Cooled Reverse-Flow Annular Combustor

Marc D. Paskin  
*Allison Engine Co.*  
*Indianapolis, Indiana*

Waldo A. Acosta  
*Vehicle Propulsion Directorate*  
*U.S. Army Research Laboratory*  
*Lewis Research Center*  
*Cleveland, Ohio*

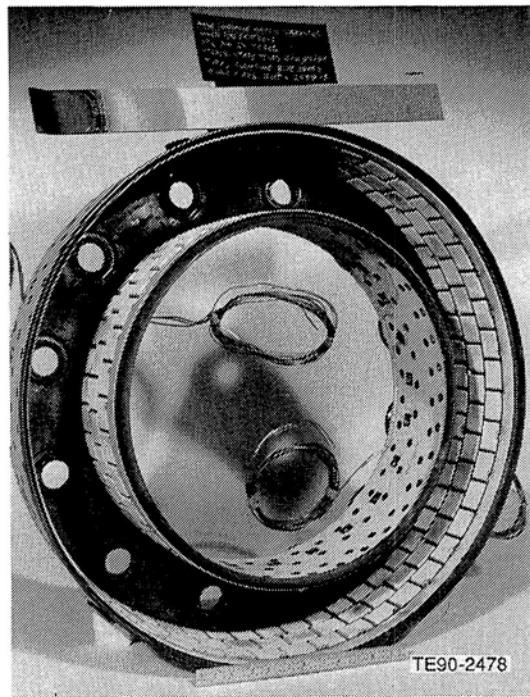
condition is given in Figure 8. As shown, no damage was sustained to the combustor hardware, and the ceramic tiles were in place with no spalling or delamination noted. The only noticeable change, other than discoloration, from the new ceramic condition were small hairline cracks on the OTL innermost two rows of tiles. Further details can be found in Reference 3.

Figure 8.—CME combustor after 1989 BU1 thermal paint test.

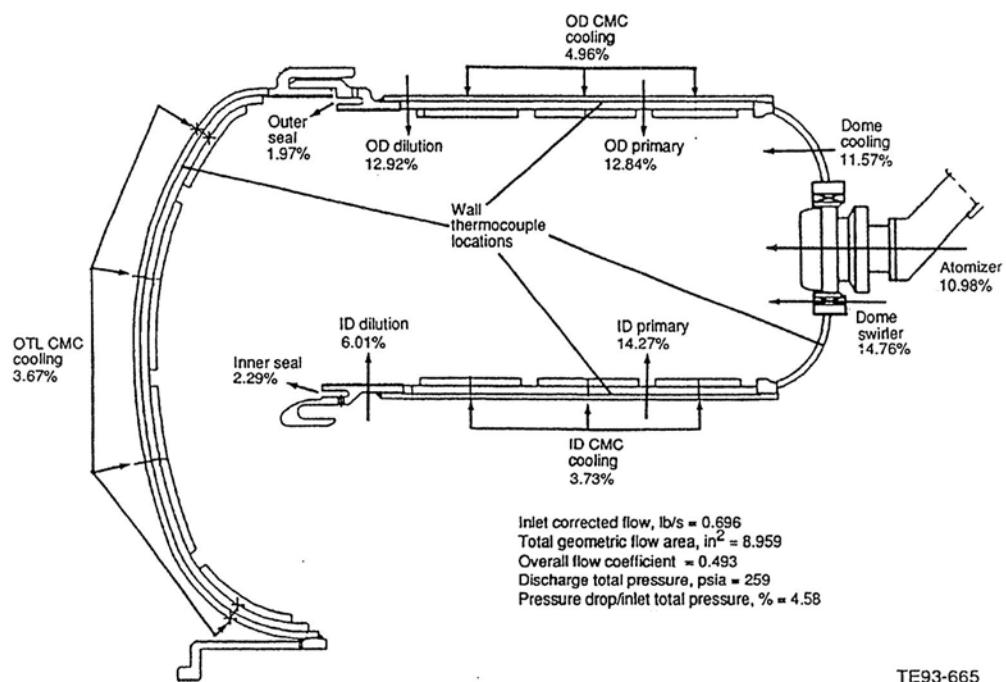
Exhaustive investigation of the cause of the hot streak and cold spikes did not yield a conclusive cause. The best conclusion, based on review of the data, was that an air leak occurred near the inner liner-rig seal interface and was possibly related to improper rig assembly. In addition, to rule out effects from the air-cooled BOT thermocouple probes, BU-3 test plans were modified to include combustor operation at the BU-1 condition (point 12, MCP, Table III), with and without thermocouple probe cooling air active.

Figure 9 provides the overall CME combustor airflow distribution following rework. Comparison with Figure 2 shows cooling flow for the dome and OTL was increased by more than 2% each and the total effective area of the liner has been increased by nearly 0.1 in<sup>2</sup>.

Figure 9.—CME combustor predicted airflow distribution at design point—after rework.

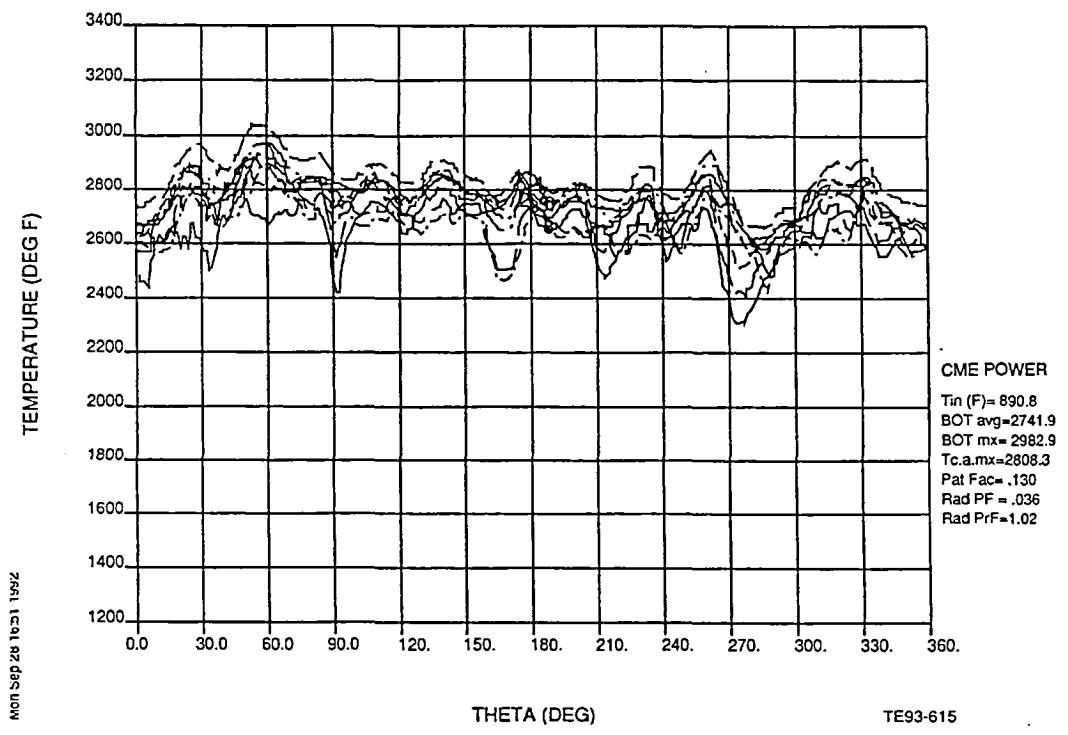
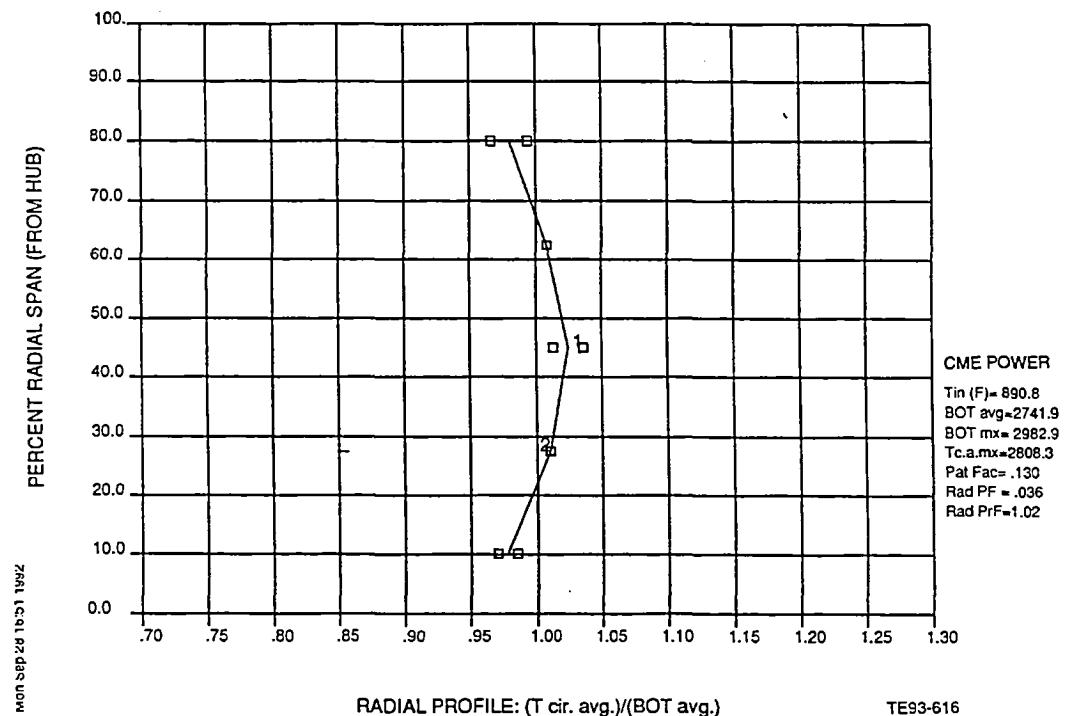
The circumferential and radial BOT traces for the 2800°F (1811 K) condition are provided in Figures 12 and 13, and for the 3000°F (1922 K) BOT condition in Figures 14 and 15. Review of the data indicates liner pressure drop falls directly on the predicted line for the post re-worked combustor. At

the corrected flow of 0.680 - 0.695, the measured liner pressure drop was 4.7 to 5.0%. Pattern factor was calculated as 0.130 for the 2800°F (1811 K) BOT condition (compared to 0.218 for BU-2) and 0.156 at the 3000°F (1922 K) condition. Radial profile was consistent with the acceptable results obtained during previous testing.

Figure 12.—Circumferential temperature trace at 2800 °F (1811K) burner outlet temperature steady-state condition.

Figure 13.—Radial temperature profile at 2800 °F (1811K) burner outlet temperature steady-state condition.

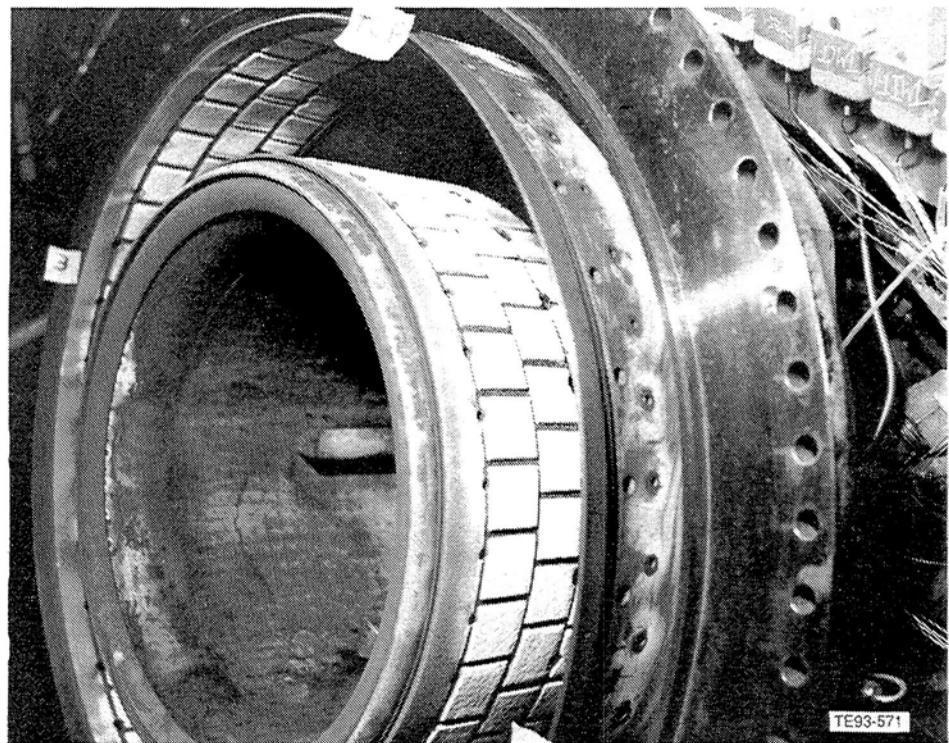
The durability of the CME cooling concept was evaluated in a series of cyclic tests. The first consisted of a 3-hr, 32 cycle thermal shock test at a maximum BOT of 2700°F (1756 K). The specific cycle is given in Figure 6. The 32 cycle test was completed without incident and inspection of the combustor and OTL revealed no apparent damage or deterioration.

Photos of the liner and OTL following the 2700°F (1756 K) BOT cyclic test are shown in Figures 16 and 17, respectively. Overall steady-state performance was consistent with other similar test points with the exception of pattern factor. Before initiation of cyclic testing, pattern factor was measured as 0.197 and increased to 0.226 following the 32nd cycle test. After comparing the BOT traces of BU-4 with BU-2, it appears that the air leak appears to have returned. Hence, a similar value of pattern factor was also obtained. The cause of the leak may be related to rig assembly or possibly mechanical distortion from the severe 3000°F (1922 K) average temperature of BU-3.

Figure 16.—CME combustor after 9/29/92 2700 °F BOT cyclic shock test—liner.

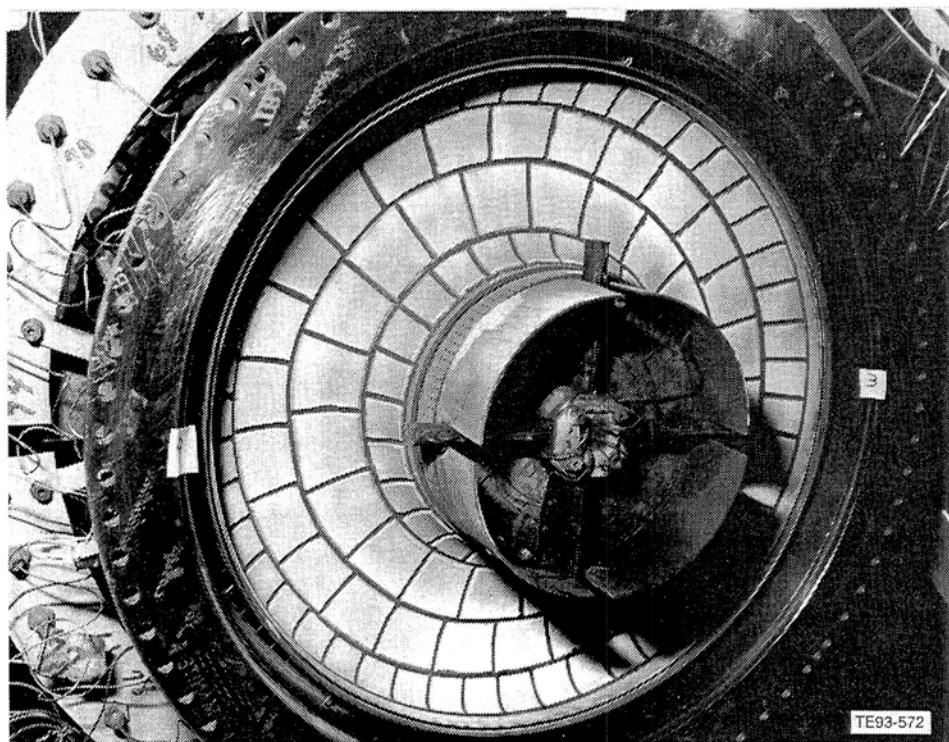
Figure 17.—CME combustor after 9/29/92 2700 °F BOT cyclic shock test—OTL.

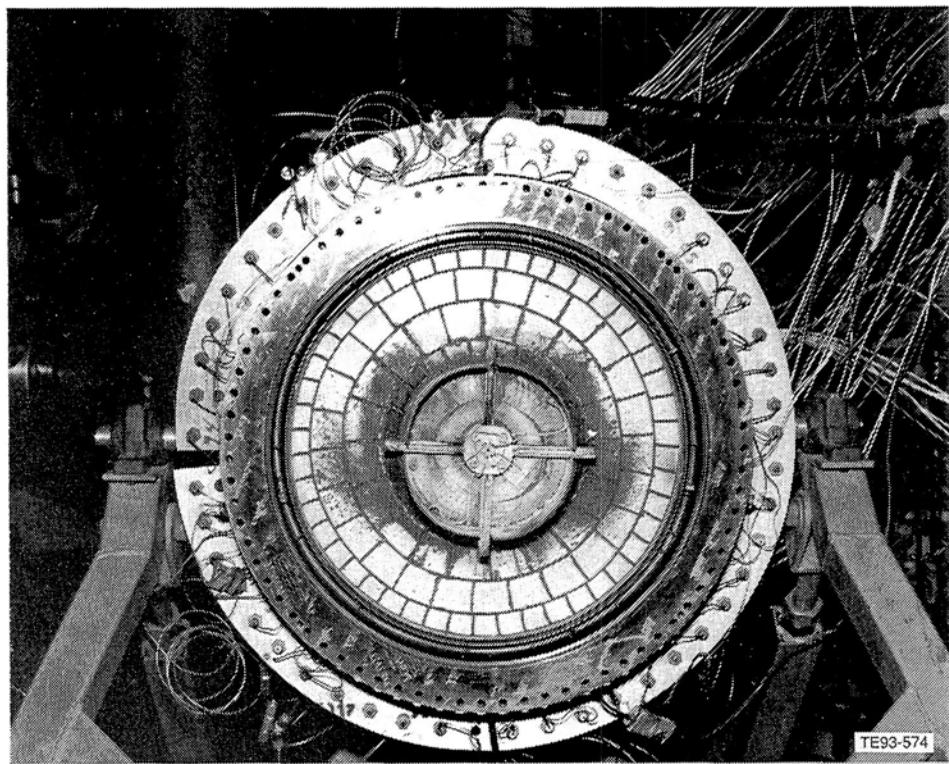
During the 68th cycle, as fuel was increased to attain 3000°F (1922 K) BOT condition, a sudden over temperature was observed. Rig inspection revealed that the axial swirler at the No. 4 fuel nozzle position was mechanically displaced. The over temperature caused the inner liner-to-rig seal to melt, which deposited on the OTL as shown in Figure 22. In spite of the severe temperature conditions, the outer liner ceramic tiles survived relatively intact. A view of the outer liner tiles, showing discoloration and through-the-plane cracking is provided in Figure 23. On the other hand, much more damage was sustained to the inner wall tiles where a view is given in Figure 24. This was attributed to the starvation of coolant flow on the inner wall when the swirler failed. Because of the reverse-flow design, inlet air enters at the outer wall and must flow across the combustor dome before turning and entering the inner wall

plenum. With the open area surrounding fuel nozzle 4, it is suspected air would preferentially enter the opening and consequently starve the inner wall of coolant air. This likely exasperated the failure of the inner seal which may have led to the type of mechanical distortion observed around the dome.

Figure 22.—CME combustor after 10/02/92 3000 °F BOT cyclic shock test—OTL.

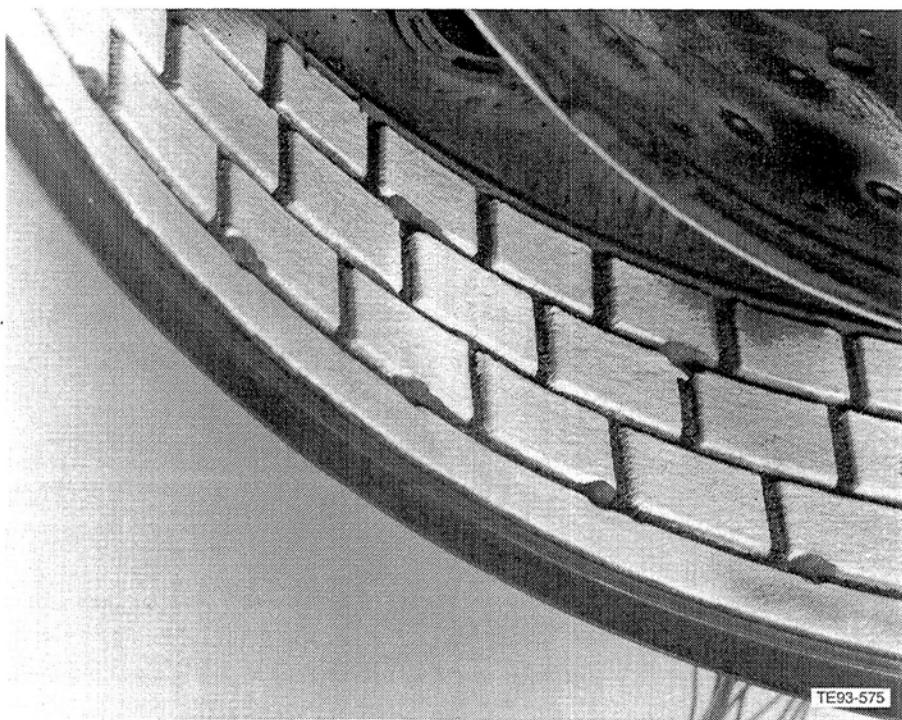
Figure 23.—CME combustor outer wall after 10/02/92 3000 °F BOT cyclic shock test.

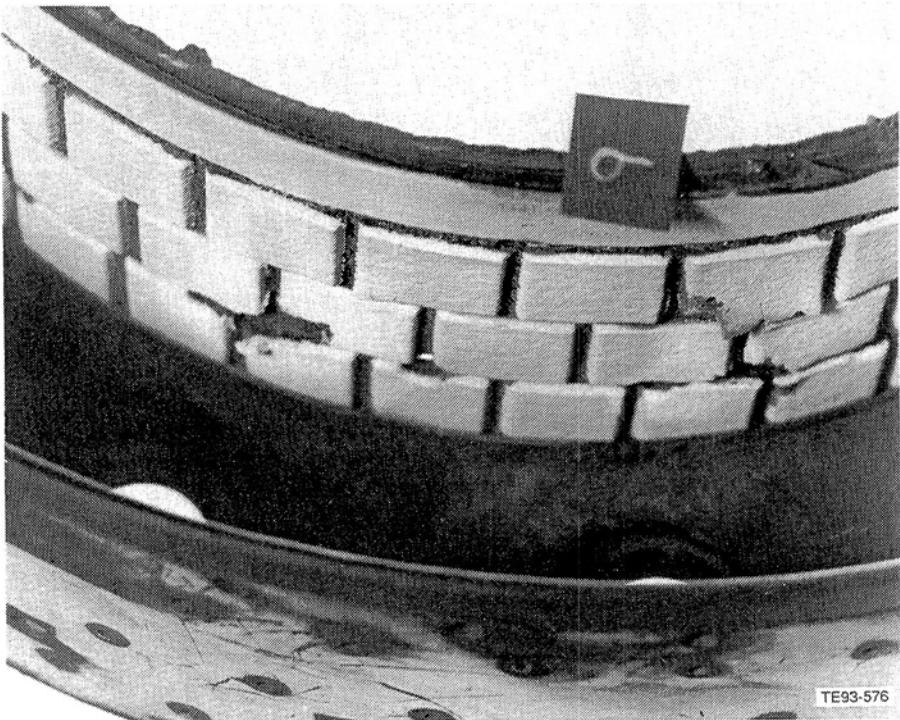
Figure 24.—CME combustor inner wall after 10/02/92 3000 °F BOT cyclic shock test.
